# Dialysis Access and Recirculation

## Arteriovenous Dialysis Access: Evaluation and Placement

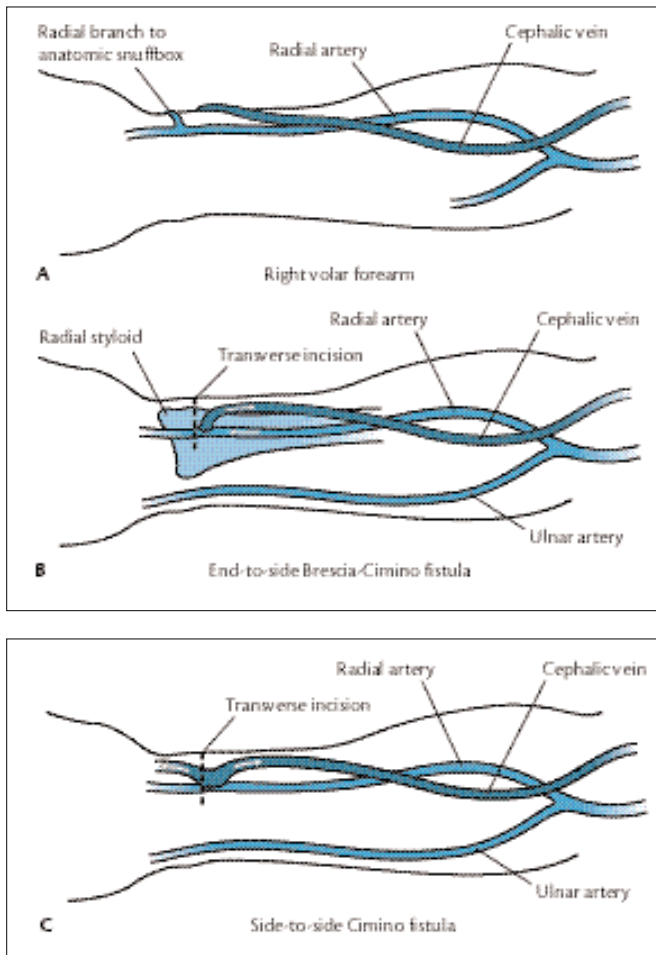
**FIGURE 5-1**

Evaluation for hemodialysis access. The creation of optimal vascular access requires an integrated approach among patient, nephrologist, and surgeon. The preoperative evaluation includes a thorough history and physical examination. A history of arterial and venous line placements should be sought. The upper extremities are examined for edema and asymmetry of pulse and blood pressure. Access should be placed at the wrist only after it is verified that the radial artery is not the dominant arterial conduit to the hand. The classic study is the Allen test, in which an observer compresses both the radial and ulnar arteries, has the patient exercise the hand by opening and closing to cause blanching, then releases one vessel to be certain that the fingers become perfused. An alternative, and perhaps more precise, test is to verify by Doppler imaging that flow to all digits is maintained despite occlusion of the radial artery. If indicated, vascular imaging studies should be used to delineate the vascular anatomy and rule out arterial or venous disease. Clinically silent stenosis involving the central veins is becoming increasingly common with the improved survival of critically ill patients for whom central vein catheters are commonplace.

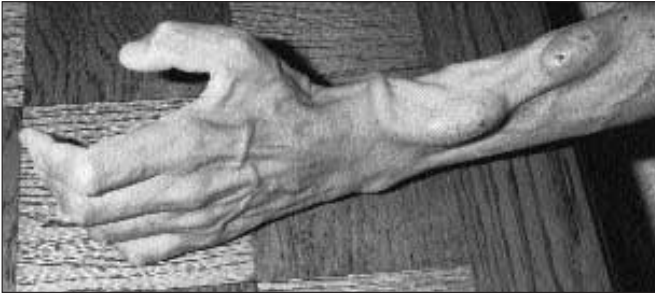
**FIGURE 5-2**

Creation of a Brescia-Cimino (radial-cephalic) fistula. The native vein arteriovenous fistula is the preferred choice for hemodialysis access. This simple and effective procedure, in which an artery is connected to an adjacent vein to provide a large volume of blood flow into the superficial venous system, has become less common in recent years. The ideal artery has minimal wall calcification, so that dilation can occur with time and allow unimpeded flow. In addition, the artery should not be affected by proximal stenosis, the most common site being an ostial lesion in the subclavian artery. Ideally, the outflow vein is subjected to minimal dissection or manipulation during the surgical procedure. Forcible distension of veins and rough handling of arteries leads to formation of neointimal fibrous hyperplasia and localized stenosis.

The first autogenous access site described was radial-cephalic at the level of the radial styloid process. These can be constructed end-vein to side-artery, **A** and **B**, or side-to-side, **C**, between the two vessels. The exposure is conveniently obtained using a transverse incision at the wrist, just proximal to the radial styloid process, where the artery and cephalic vein lie close to one another. In general, the two vessels are just far enough apart so that an end-to-side technique is best. When the vessels overlap each other, some surgeons prefer the side-to-side technique, which allows reversal of blood flow into the dorsum of the hand and then via collaterals into the forearm, theoretically leading to better flow volume over time.

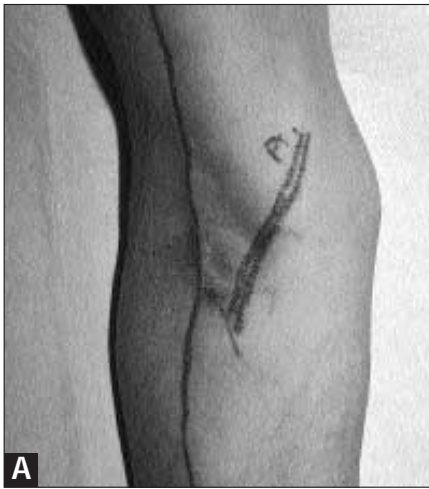
**FIGURE 5-3**

The Brescia-Cimino (radial-cephalic) fistula. The radial-cephalic fistula offers many advantages. It is simple to create and preserves more proximal vessels for future access construction. The lower

incidence of steal is likely the result of the lower flow rate associated with these accesses. Additionally, such accesses have low rates of thrombosis and infection. The photograph shows a mature Brescia-Cimino fistula in a patient with longstanding diabetes. The fistula outflow vein has numerous aneurysmal segments, and, although they are associated with some tendency toward flow stagnation, they are of no harm to the patient's dialysis life. They do, however, become obvious targets for the dialysis technical staff, who have a tendency to puncture them repeatedly rather than to utilize new needle insertion sites. The patient's arm also demonstrates marked muscle atrophy secondary to advanced diabetic neuropathy, which particularly involves the thenar eminence and the interosseus muscle groups. Complaints of weakness and loss of grip strength in the arm are common and may represent symptoms of steal. In this case, however, the symptoms are due to the intrinsic loss of muscle mass, rather than to steal.

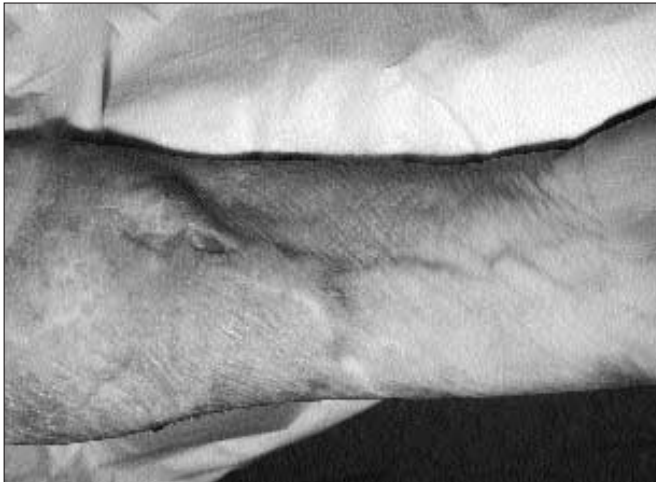
**FIGURE 5-8**

Exposed polytetrafluoroethylene (PTFE) graft. Proper placement of a PTFE graft is crucial for its long-term survival. The graft cannot be too short, as it will deteriorate quickly from puncture limited to only a few sites; if it is too long, however, it will have a greater impedance to flow and a tendency toward thrombosis. The graft should be neither too deep to the skin nor too shallow. When the graft is too shallow, puncture by the dialysis staff is easier, but the skin may be eroded with scarring from repeated use. This photograph shows a linear forearm graft with a segment of exposed PTFE. An exposed graft is a serious problem for several reasons. First, exposure of actual puncture holes eventually leads to hemorrhage. Second, an exposed graft is, by definition, infected. Although some cases have been treated successfully with rotational skin flaps and a long course of antibiotics, the majority do not heal. The ideal treatment is removal of the segment of exposed graft, splicing a segment of new PTFE away from the site of exposure, and allowing secondary wound healing.

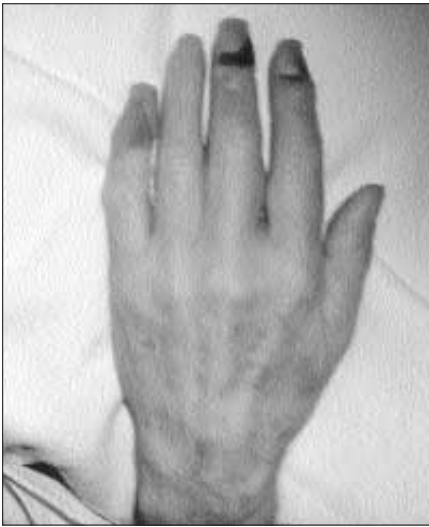
**FIGURE 5-17**

**Vascular steal.** Vascular steal is a common problem of dialysis access sites. The principle of steal is related to two phenomena: 1) calcification or stenosis in the inflow arterial segment proximal to an access site (so that the native artery cannot dilate to meet the increasing demands for flow volume); 2) and an outflow arterial bed in parallel to the fistula origin with higher net vascular resistance than the fistula conduit. If both of these are present, blood flow is diverted to the access site in association with a drop in perfusion pressure to the most acral tissues, the fingers. When steal is severe, trauma to the digits leads to gangrene. Several treatment strategies are available to the surgeon. The access can be “banded,” or purposefully stenosed at its origin to divert flow to the ischemic site. The access can be revised using a tapered graft or the point of origin of the access can be moved more proximally in the arterial tree, in the hope of allowing full flow without diverting distal perfusion pressure. Additionally, one can perform a variety of bypass procedures to divert higher-pressure proximal blood to increase distal perfusion pressure. In severe cases, either the access or the distal digits may be sacrificed to preserve the other.

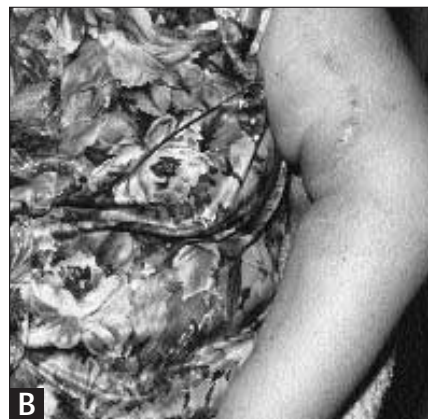
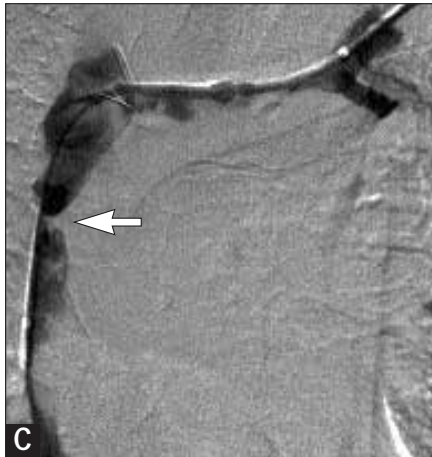
**FIGURE 5-20**

Central vein stenosis. **A**, Venogram of the central outflow veins performed in a patient with a left upper extremity polytetrafluoroethylene graft and arm edema, **B**.

The angiogram (*Panel A*) demonstrates complete occlusion of the innominate vein (*arrow*) with collateral filling in the neck and the chest. The most common cause for stenosis or thrombosis of the central venous system is previous injury from indwelling central vein catheters. Central vein stenosis may not become apparent until an arteriovenous anastomosis is created. This increases blood flow in the outflow veins and may overwhelm a compromised central vein, resulting in the appearance of superficial collateral veins on the neck and chest wall in addition to ipsilateral arm edema. In this example, the occlusion was crossed using an angiographic catheter, and thrombolytic therapy was administered. **C**, Venography performed after thrombolysis demonstrates severe stenosis of the innominate vein and the superior vena cava (*arrow*).

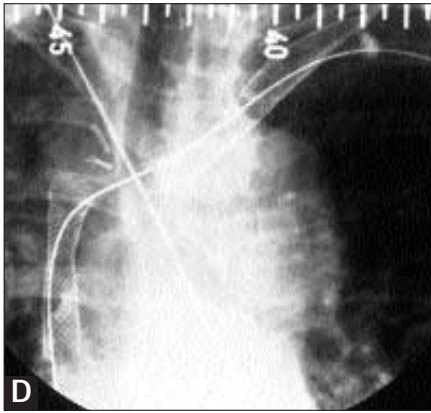
**FIGURE 5-21**

Stent deployment. When angioplasty fails, metal stents are introduced to treat outflow vein occlusion. These stents are either balloon expandable or self-expanding. The stages of deployment of the self-expanding Wallstent (Schneider, Inc, Division of Pfizer Hospital Products, Minneapolis, MN) are seen in these radiographs. **A**, The radiopaque stent is positioned across the lesion to be treated. **B**, As the deployment envelope is gradually withdrawn, the stent begins to expand (*arrow*). These stents shorten during deployment, and this factor must be taken into consideration for proper placement. **C**, An angioplasty balloon (*arrow*) is placed in the proximal portion of this completely deployed stent to achieve further expansion.

**D**, To improve central vein patency following angioplasty, metal stents have been placed in the innominate vein and the superior vena cava. **E**, A postprocedure venogram demonstrates no residual stenosis.

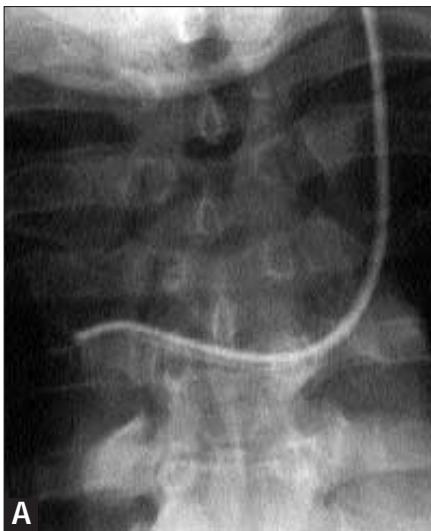
**FIGURE 5-22**

Central vein catheter complications. **A**, This radiograph demonstrates the tip of this dialysis catheter abutting the wall of the left innominate vein at its junction with the superior vena cava. To maintain adequate dialysis flow rates and minimize fibrin sheath formation, it is important for the catheter tip to be in the superior vena cava, near or in the right atrium. **B** and **C**, Injection of contrast through these dialysis catheters demonstrates the contrast outlining the outside of the distal portion of the catheter (*arrows*). This finding is characteristic of a fibrin sheath with contrast medium trapped between the fibrin sheath and the outer wall of the catheter. Fibrin sheaths are associated with a reduction (often severe) in the achievable blood flow rate and, as a result, inadequate dialysis delivery. They can be lysed by instilling large doses of urokinase (typically 250,000 units) through the catheter ports. If thrombolytic therapy is unsuccessful, the fibrin sheath can be stripped using a snare loop. Although these catheters can function remarkably well, they are prone to thrombosis.

**D**, The clot is typical of one that is remarkably tenacious. Before replacement of this catheter, a variety of manipulations were performed, including attempted thrombolysis with localized infusion of urokinase. A new catheter was placed in the same site in a same-day procedure using local anesthesia.
